BELZONA REPAIRS AND PROTECTS CHIMNEY MASONRY

Flue gas chimney stack.

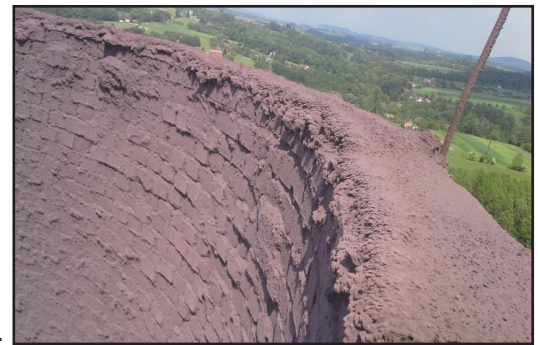
The top of the stack had deteriorated due to flue gas and water ingress, causing the mortar to break down and bricks to become loose.

1. The deteriorated stack.
2. Work underway.
3. The sheet metal formers with finished Belzona 4111.
4. The finished job with Belzona 4341 coating.
