BLAST FURNACE GAS LEAK PIPE REPAIR

Steel plant blast furnace gas inlet.

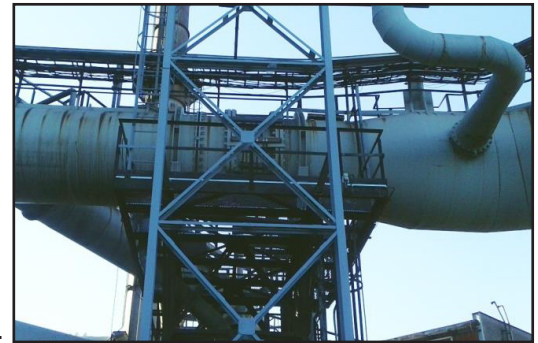
Steel plant blast furnace gas inlet had developed a leak and was losing pressure. The repair needed to be done whilst equipment was online.

1. The blast furnace gas inlet.
2. The repair is underway.
3. The finished repair.
