HEALTH DISTRICT HVAC TUBE SHEET REPAIRED WITH BELZONA

APPLICATION SITUATION
A tube sheet of an HVAC system of New Zealand's biggest district health board. A severely corroded tube sheet in a district health board.

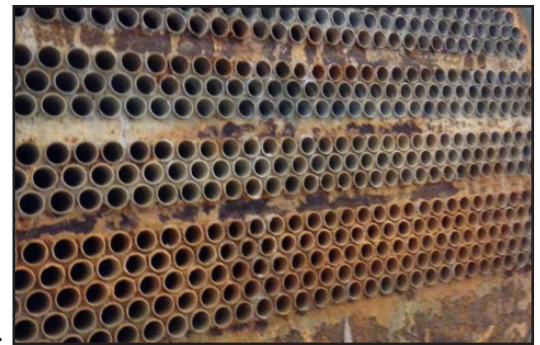
PROBLEM
The tube sheet was severely corroded.

- PICTURES**
1. Corroded tube sheet before application.
 2. Tube sheet after blasting.
 3. Belzona 1111 application onto the tube sheet.
 4. Completed application.
