BELZONA REPAIRS AND PROTECTS THE ROOF OF STORAGE SILOS

Asphalt coated roofs of four storage silos.

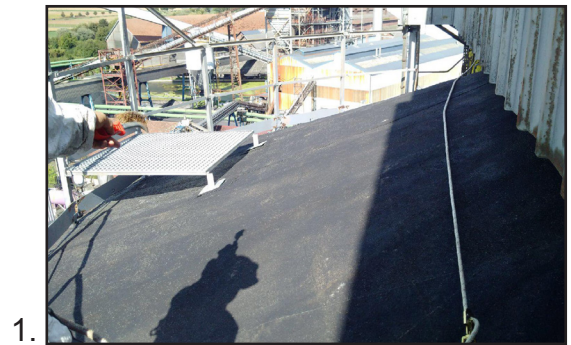
1. Previous asphalt coating used for roof protection.
2. Belzona 3111 used on the previous coating welds.
3. Final application.
4. Overview of the silos.
