## BELZONA REPAIRS TANK LEG SUPPORTS AT A DISTILLERY

VAT tank leg supports at a distillery.

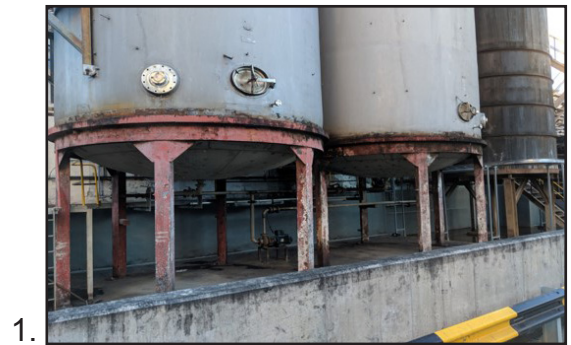
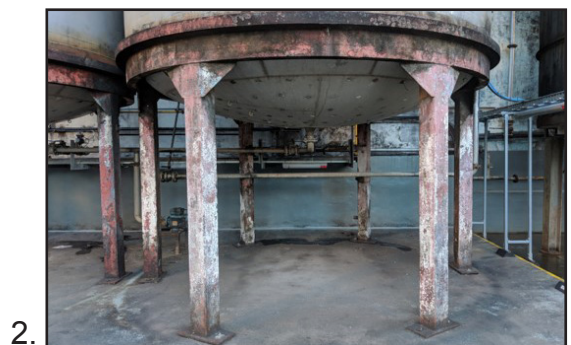
Several VAT tank leg supports were corroded due to the break down of the original paint system. Some tanks had already been condemned due to metal loss and through wall defects in the tank supports.

1. Damaged tank leg supports.
2. Damaged tank leg supports.
3. 1st coat of Belzona 5811.
4. Completed application

The previous paint was removed by saturation blasting to keep the dust levels down on-site. The VAT legs were then coated by hand with Belzona 5811 in accordance with a modified version of Belzona Know-How System Leaflet TCC-5.
