BELZONA CHOCKING COMPOUND STABILIZES A LATHE

APPLICATION SITUATION
Newly installed lathe at a paper manufacturer required a solid foundation.

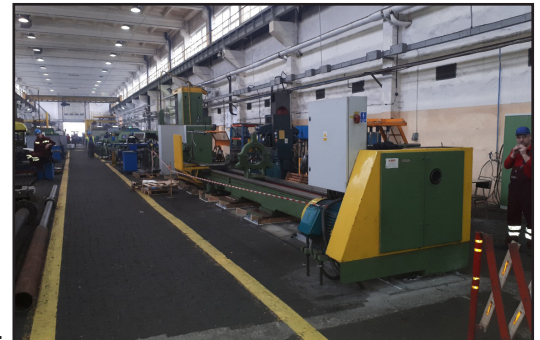
1. The new lathe to be chocked.
2. The application is underway.
3. The completed solution.
