MEAT PROCESSING PLANT IN NEED OF BELZONA ON COOLING TOWERS

CUSTOMER
Florida, USA

APPLICATION DATE
December 4-9, 2017

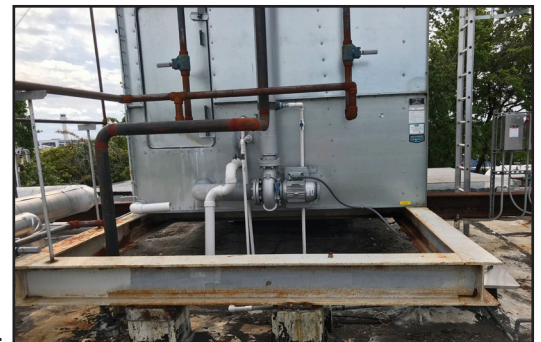
APPLICATION SITUATION
The customer had acquired and installed a brand new cooling tower on an existing corroded framework. Piping system was also corroded.

- PICTURES**
1. Framework and piping before surface preparation.
 2. Ongoing surface preparation using grit-blasting.
 3. Framework after application of Belzona 5811 and Belzona 5111.
 4. Piping after application of Belzona 3921 and Belzona 5111.

APPLICATION METHOD
Application carried out in accordance to a modified version of TCC-05. Framework was grit-blasted to NACE 2 Standard. One coat of Belzona 5811 and two coats Belzona 5111 were applied. Some sections of the framework were inaccessible for coating and -in lieu- the access point was sealed with Belzona 3111. Piping system was prepared using power tools. One coat of Belzona 3921 and two coats of Belzona 5111 were applied.
