BELZONA REPAIR OF RAIL PRINT INTERFACE ON A SINGLE POINT MOORING TURRET

Repair of the support flange for the rail on a mooring buoy turret.

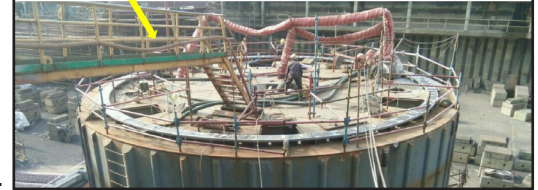
Severe pitting, galvanic and crevice corrosion on the rail support flange. Welding was not an option due to the location of the damage and the need for the surface to be accurately flat for the proper sitting of the rails.

1. Single Point Mooring Buoy and problem area.
2. Details of the pitting/crevice corrosion underneath the rail
3. Surface preparation and application.
4. Completed application.
