BELZONA REPAIRS AND PROTECTS A SAND FILTER IN A SWIMMING POOL

Inside of a filter in a swimming pool damaged by corrosion and chemical attack.

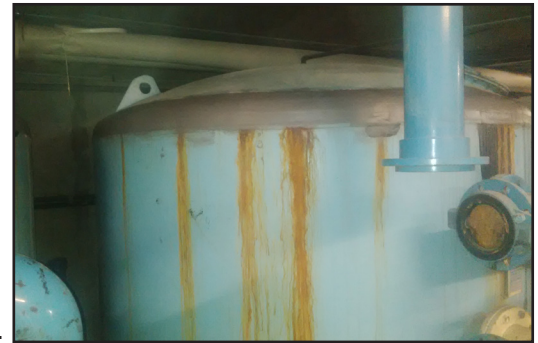
The inside of this sand filter in a swimming pool was badly damaged by corrosion and chemical attacks, especially chloride. After grit blasting the substrate, through-wall defects were found.

1. Before application.
2. Repair using Belzona 1111.
3. Application after using Belzona SuperWrap II.
4. Final application.
