NEW TRANE CHILLER PROTECTED WITH BELZONA

Manufacturing Plant, Alabama, USA

December 2017

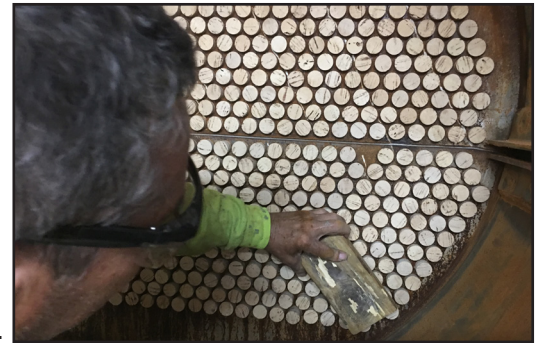
1. Corks were added before blasting. Then the unit was blasted.
2. More corks were added then ground down flush since the copper tubes were flush with the sheet. All seams were sealed with 1121.
3. Care was taken to seal the ends of the inserts so no water could enter during operation and cause rusting from the inside out.
4. Both ends of the chiller and the water boxes were coated and the corks were blown out and the tubes cleaned out to turn over to the owner.

The application was carried out in accordance with Belzona Know-How System Leaflets HEX-1, HEX-2, and HEX-3. Belzona 1121 was used to seal all the seams before coating, Belzona 1321 was applied in two coats after Belzona 1121 was cured. The product was applied by hand. Corks were inserted before blasting then again before coating to protect the copper tubes. The water boxes were also coated.
