## BELZONA REBUILDS STRIPPED THREADS AT POWER GENERATOR

Stripped threads on a door at a power plant.

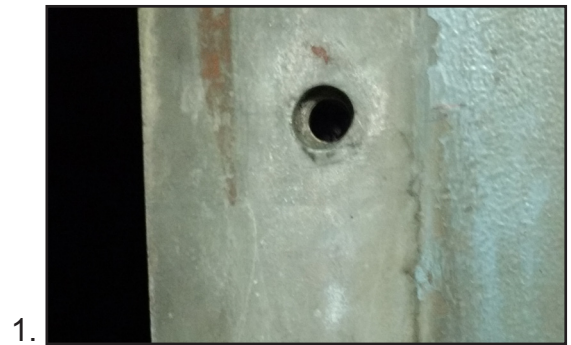
The door to an industrial blower had quite a few bolts intended to hold the door shut during operation. However over the years of operation and maintenance many of these bolt holes had become stripped and were not firmly holding the door shut.

1. Bolt holes to be repaired by building new threads.
2. Coating male bolts with Belzona 9411.
3. Coated bolts drying.
4. Completed applicaion.

The application was carried out in accordance with Belzona Know-How System Leaflet ENC-2. The new bolt was coated with 2 coats of Belzona 9411 and allowed to dry for 30 minutes. While the bolt was drying, the bolt cavity was cleaned using a round wire brush and a Cleaner/Degreaser. A die grinder with a roughening bit was used to abraid the inner surface of the female bolt holes. Belzona 1111 was then applied to both the female bolt holes as well as to the new male threads that had been coated with Belzona 9411. The coated bolts were then turned into place to incorporate the materials in the female hole and on the male bolt. Once Belzona 1111 was fully cured the male bolts could be removed with a wrench or socket due to the presence of the Release agent and the threads were rebuilt.
