BELZONA PROTECTS A STAINLESS STEEL WATER PIPE

Oklahoma, USA

October 2017

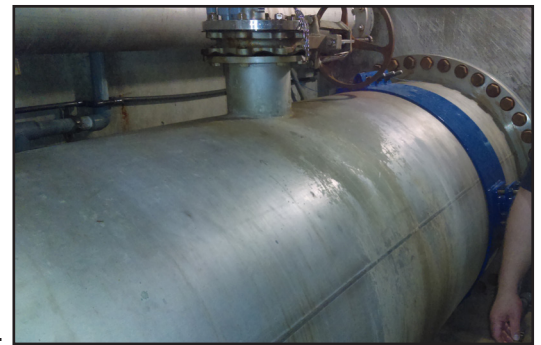
A water treatment plant in Oklahoma serving about 100,000 residents uses 1% bleach as part of their treatment process. A PVC pipe carrying the bleach solution runs above two stainless steel water pipes. The PVC pipe developed a slow leak that was not immediately discovered.

The bleach solution dripped onto the stainless steel pipes over time, causing corrosion and pitting damage. Further damage to the stainless steel pipes could cause a leak, possibly requiring a plant shutdown and leaving thousands of residents without water.

1. 48" and 12" stainless steel pipes, small PVC pipe carrying bleach solution
2. Surfaces cleaned and prepared, Belzona 1151 applied to the damaged area on the back side of the 48" pipe
3. Applying the first coat of Belzona 4311
4. Completed application
