## TRANSFORMER DAMAGED BY A FORKLIFT REPAIRED WITH BELZONA

**APPLICATION SITUATION**  
Electrical transformer cooling fin damaged by a forklift at a local recycling center.

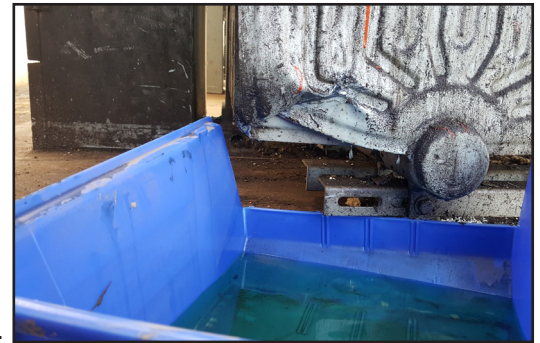
**PROBLEM**  
Forklift hit the cooling fins on an electrical transformer causing a serious oil leak.

- PICTURES**
1. Note the oil dripping.
  2. Damage is severe, bending the cooling fin.
  3. & 4. Belzona 1212 applied, repair complete.
