BELZONA APPLIES A PROTECTIVE SYSTEM ON A GRIT SNAIL

CUSTOMER
Oregon, USA

APPLICATION DATE
January, 2018

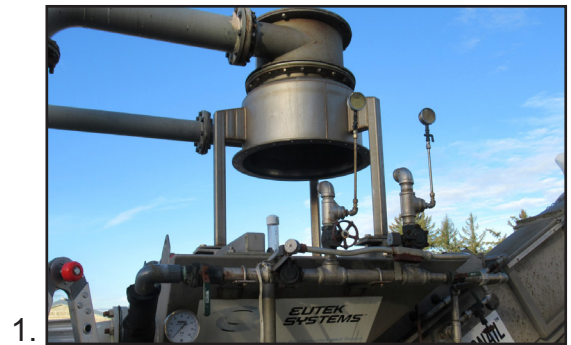
1. Grit Snail
2. Worn area inside grit bowl.
3. & 4. Belzona 1811 (Ceramic Carbide) replaced.

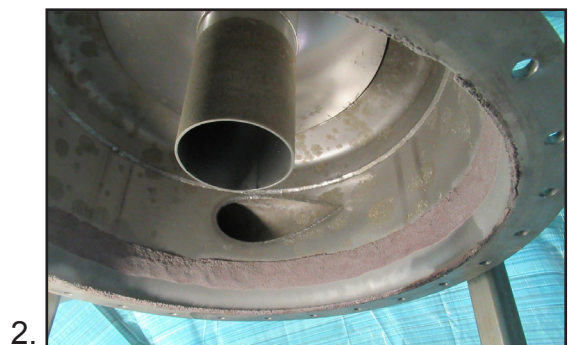
The grit removal system, called a Grit Snail, in a waste water treatment plant malfunctioned. The timer had quit working causing the Grit Snail to run constantly causing the factory installed sacrificial coating to wear prematurely through the coating in to the stainless steel housing.

Grit running through the grit removal system wears through the protective coating and the stainless steel housing.

The stainless steel and remaining Belzona 1811 are grit blasted. The 1811 is mixed and applied 1/4" thick on the edges and slightly thicker in the center.
