BELZONA 3111 SUCCESSFULLY HANDLES AN INTRICATE DESIGN OF A CHURCH DOME-SHAPED ROOF

Church, Virginia, USA

September 2017

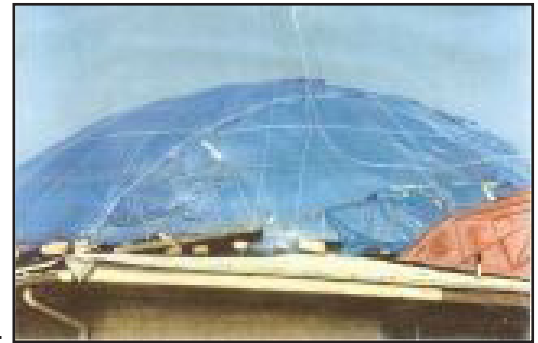
1. Image of the original roof repair back in 1980s.
2. View of one of the domes, showing intricates of the roof design.
3. Complete application.
