## BELZONA COLD BONDING REPAIRS AN EXHAUST FLUE

Zinc and Lead Smelting Complex, BC, Canada

Hot exhaust gas flue.

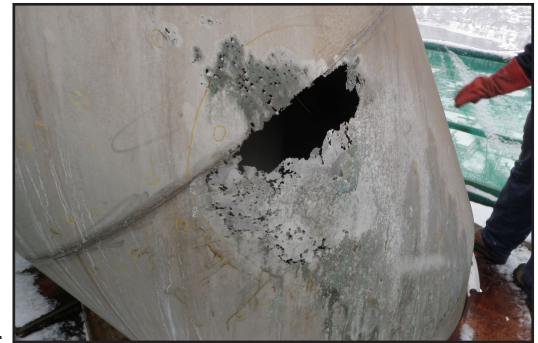
A hole was created in the wall of the flue at an elbow; due to the location of the hole, it was not noticed until it was nearly one foot across. Upon closer inspection, it was found that a large section of the flue wall in this area was pitted and weakened, with many small holes developing.

1. View of small holes indicating extensive pitting of the interior surface.
2. Initial surface preparation using a wire brush.
3. Prepared area coated with Belzona 5841.
4. All 5 plates bonded in place; application is completed.
