BELZONA'S CREATIVE APPROACH SAVES A REFINING COMPANY A LARGE LOSS IN REVENUE

Refinery, Texas, USA

A 30" return line for a cooling tower.

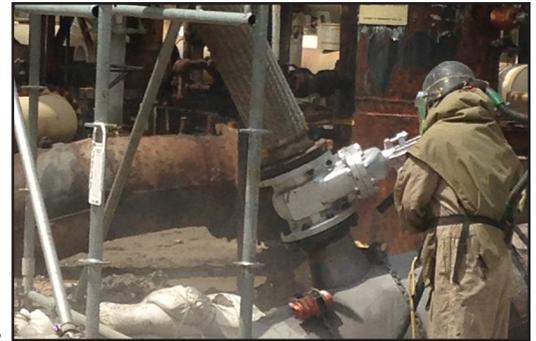
1. Half wrap blasted and prepped to have a wrap applied.
2. Belzona 1161 being applied.
3. Belzona 4141 applied to the come-alongs and chain and Belzona 1121 applied over Belzona 4141.
4. Applying the top layer of Belzona 1321 to encapsulate the repair.

The pipe was grit blasted in the application area. By use of a mini excavator, a fully assembled half wrap was positioned over the hole. Two chain come-alongs were put around the pipe and half wrap to hold down the half wrap and create a water tight seal around the neoprene seal. The neoprene seal left a 1 and 1/4 gap in-between the half wrap and the pipe. Belzona 1161 was pushed in this gap from all sides until each side was filled. This was left to cure for a couple of days with the chain come-alongs left in place. A hose was connected to the gate valve to direct the lost water back to the cooling tower so that they could perform back flush procedures. Belzona 4141 was used to encapsulate the come-alongs. Belzona 1121 and Belzona 9341 were applied over Belzona 4141. Then, a layer of Belzona 1321 was applied on top of the wrap for added protection.
