BELZONA SHAFT REPAIR PREVENTS LOSS IN REVENUE

Bearing failure had caused significant damage to the main drive shaft on carton forming machine. Replacing shaft would take up to 21 days of round-the-clock work.

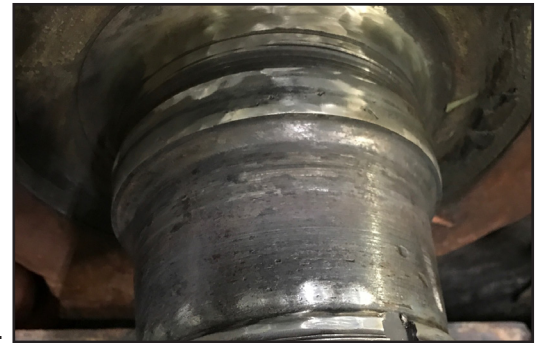
Failed bearing grooved the shaft so that the machine would not run. Shaft holds approximately 25000 pounds. Customer had replaced a shaft on similar machine and it took 3 weeks of round the clock maintenance teams to get it back up and running. The Belzona solution could be done in a day and save them potentially hundreds of thousands of dollars.

1. Damaged shaft.
2. Preparing the repair area with a bristle blaster.
3. Former injected with Belzona 1321.
4. Completed repair.
