INJECTION SAVES ROOFING MANUFACTURER TIME AND MONEY

Brampton, Ontario, Canada

October 2013

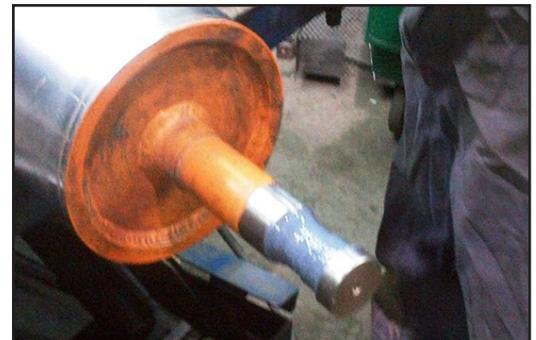
A roller in the production process had become damaged due to the failure of a bearing.

1. Damaged shaft with Belzona 1321 brush applied to the prepared substrate prior to forming technique.
2. Mixed Belzona 1321 being loaded into injection cartridge tube
3. Former showing vent ports whilst material is allowed to cure
4. Finished application with no additional machining required.

Belzona Know-How system leaflet MPT-2 for rebuilding damaged shafts using forming techniques was chosen for the repair. The application involves the manufacture of a suitable split former, which can be reused to repair additional shafts. The damaged substrate is prepared by a mechanical grinder and undercut with a minimum of 1/16 inch (1.5mm), any contamination is removed with the use of Belzona 9111. Belzona 9411 was applied to the former prior to assembly. Belzona 1321 was then mixed in accordance with the IFU and loaded into an injection cartridge for injection into the former, air is vented out of the former ensuring that the cavity is filled 100% with no voids.
