BELZONA PROVIDES A BULK REPAIR TO A MEAT FREEZER FLOOR

Meat Processing Plant, Florida, USA

December, 2017

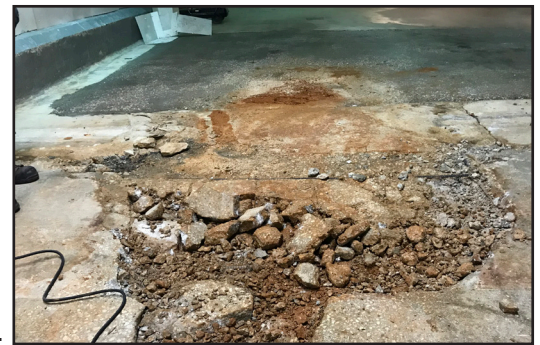
Freezer floors have been under 24/7 heavy forklift operation and freezing conditions for more than 40 years. Some areas needed major overhaul. Major concrete damage was found on floors that are indispensable for plant operation. In addition, some localized repairs were needed all over the place. Turnaround time was also an issue with only 3 days to perform repairs.

1. Condition of the floor after removing covering metal plates.
2. Surface preparation on the way.
3. Ongoing application (Belzona 4154 and pea-gravel).
4. Finished repair after Belzona 4111 application.
