## BREWERY VESSEL COATING

A large vessel containing a beer solution required an internal lining to prevent corrosion & maintain hygienic conditions within the vessel.

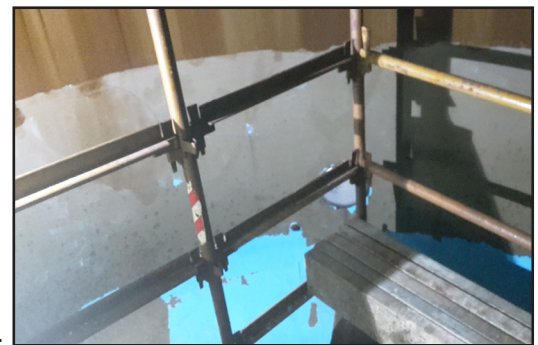
The original lining had started to break down. A corrosion resistant system that would not taint the final product was required. Dust was not permitted to escape the working area due to production going on in the surrounding area.

1. Vessel manway
2. Breakdown in original lining
3. Habitat to contain any sponge media from the blasting process
4. Belzona 5892 applied
