BELZONA PUTS SCREW CONVEYOR BACK IN ACTION

Sugar Mill, France

Screw conveyor, displacing sugar beets

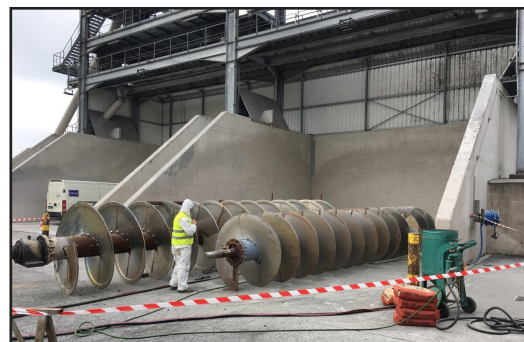
1. Screw Conveyor
2. Extend of the pitting
3. Rebuilding of the pitted areas
4. Belzona 1331 applied as a protective coating

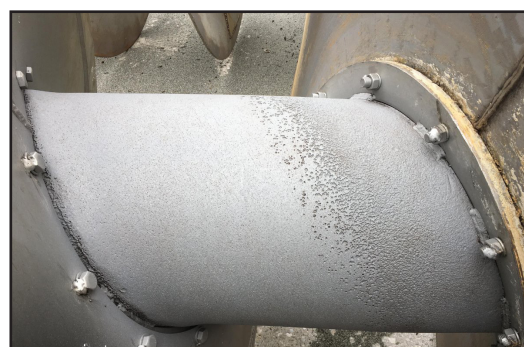
2.

Erosion/corrosion caused pitting damage on the screw conveyor surface. Damage due to the beets as well as rocks and gravels.
