## BELZONA PREVAILS AFTER SEVERAL CAMPAIGNS OF PROTECTION FOR THIS AUGER SCREW

Sugar Mill, France

Screw conveyor moving sugar beets across the plant

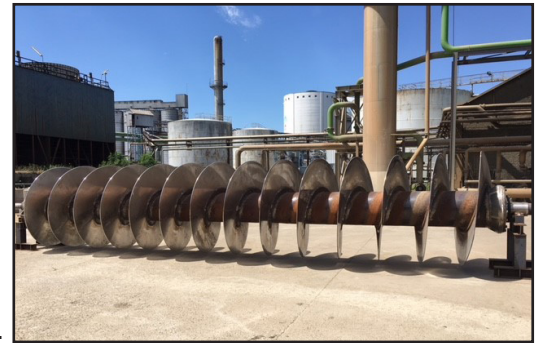
Wear due to continuous abrasion of the sugar beets as well as gravels, rocks and sand

1. Screw needed protection
2. Belzona 1321 and 1812 visible on the different section
3. Belzona 1812
4. Head of the screw protected with Belzona 1812
