NUCLEAR PLANT BENEFITS FROM BELZONA'S LONG-LASTING PUMP COATINGS

Flamanville, France

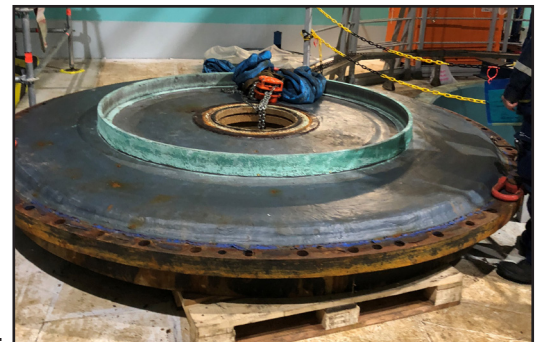
1. Pump removed from service for inspection
2. Inspection reveals the coating is still in excellent condition after 20 years
3. Coating frost blasted before application of Belzona 5821
4. Pump reinstalled with additional barrier protection

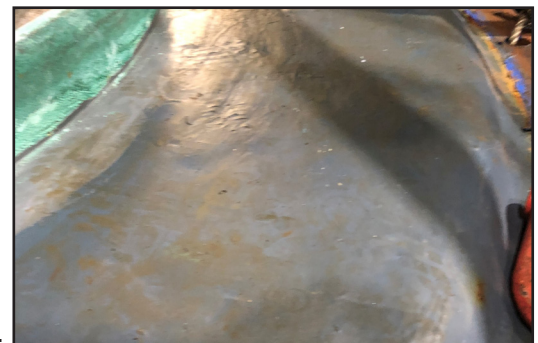
2.

This power station had been coating cooling water pumps with Belzona for over 25 years, with each application demonstrating excellent erosion-corrosion resistance over that period. In this instance, the application was no different. Originally instated in 1998, the pump and coating were inspected 20 years later and found to still be in excellent condition. As a future-proofing measure, the Belzona Distributor frost blasted the coating and applied an additional layer of Belzona 5821 before returning to service. This high-performance system is ideally suited for equipment operating under immersion and erosive conditions and will extend the pump's life expectancy well beyond its original prescription.
