## BED PLATE OF PRESSING MACHINE REBUILT WITH BELZONA

Bed plate of press used to accurately form the thickness of rubber sheet.

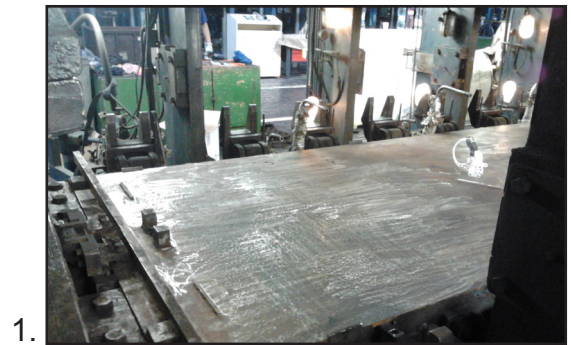
1. Surface preparation
2. Belzona 1111 being applied
3. The plate ready for leveling by grinding

Application was carried out in accordance with Belzona Know-How System Leaflet ENC-7. After Belzona 1111 application it was necessary to level the plate by grinding.
