BELZONA REPAIRS MOULD FLANGE

Aluminium producer, Slovakia

Mould used in production of anodes.

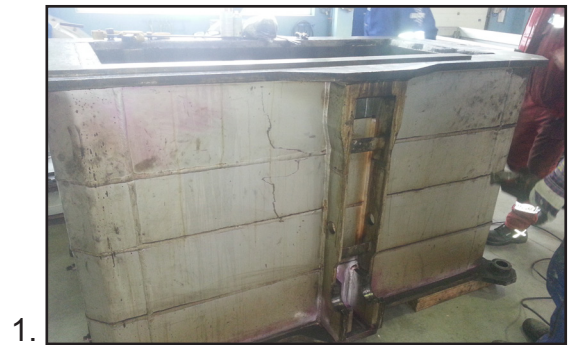
During mould manipulation workers damaged the flange leading to loss of critical dimension.

1. Mould has massive construction
2. Surface preparation
3. Belzona 1111 application
4. Final grinding to achieve correct level

Because the mould has massive construction it was not possible to bend sealing face back. Welding would have taken a long time. Repair with Belzona 1111 was done very quickly.
