## LARGE STORAGE TANK PROTECTED WITH BELZONA

Crude oil storage tank

The tank had been in service for twenty years and was suffering extensive corrosion damage

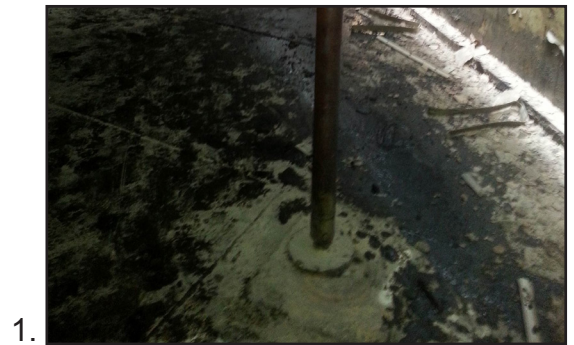
1. Tank after 20 years.
2. Blasting of the basin
3. Visible damages after blasting
4. Belzona 5811 coating applied in 2 layers
