BELZONA REFURBISHES BRAKE TEST ROLLERS

Vehicle testing station, Slovakia

Brake test rollers at vehicle testing station.

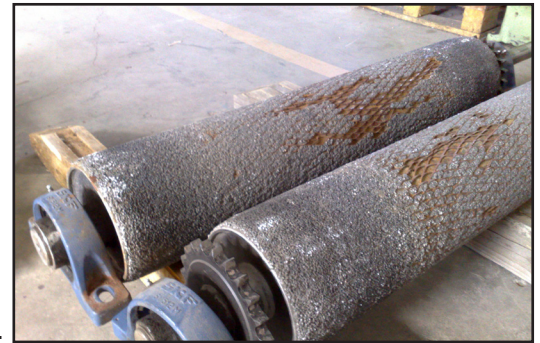
After many thousand tests the surface of the rollers required a new non-slip surface applying.

1. Damaged rollers
2. Belzona 9211 Supergrip Aggregate application into Belzona 1821
3. Ready to work
