BELZONA SAVES A CEMENT SILO LID

Concrete products manufacturer, Bedfordshire, UK

August 2017

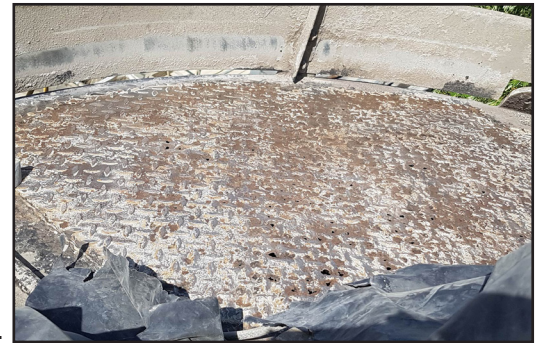
Any moisture ingress will ruin the stored materials. The customer had noticed problems and after inspecting found that the lid was severely corroded and was letting in rainwater. The silo is 11 metres high, to replace the lid would be logistically very difficult and incredibly expensive.

1. The silo lid at the start of the repairs
2. A closer look at the damage
3. The lid repaired with Belzona 1111 plate bonding techniques
4. The finished lid after application of Belzona 5811

Application was carried out in accordance with Belzona System Leaflets TCC-1 and TCC-5. Steel plates were bonded to the lid using B1111 where required to repair the holed areas before applying two coats of Belzona 5811 to provide overall corrosion protection.
