BELZONA REPAIRS JOINTS IN CONCRETE

Furniture production plant, Slovakia,

Dilatation (contraction) joints in concrete floor.

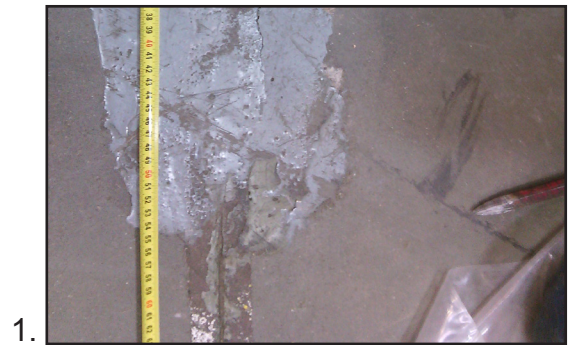
Heavy fork lift truck traffic destroyed joint nosings.

1. Damaged dilatation joint
2. Repair in progress
3. Belzona 2211 application
4. Joints ready for work
