VACUUM DRUM PIVOTS REPAIRED WITH BELZONA

Cellulose producer, Slovakia,

vacuum drying drum used in cellulose production

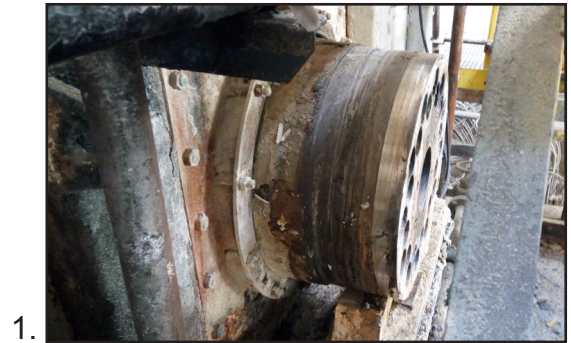
After long time in service the pivot/shaft had become badly worn aggravated by corrosion.

1. Damaged pivot
2. Cleaning and preparing
3. Belzona 1111 after application
4. Drum installed and ready to work
