BELZONA TOP UP AFTER 3 YEARS SERVICE

Condensate extractor pumps carrying water contaminated with H₂S and SO₂ at Geothermal Power Plant.

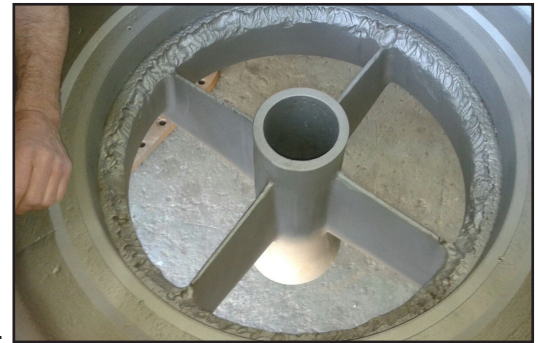
Impingement erosion coupled with corrosion from the contaminated water had caused significant metal loss to various areas of the pump housing. Damage was most noticeable around the flow straighteners, where turbulent flow had increased the rate of erosion.

1. Erosion / Corrosion damage
2. Crack ends drill tapped and terminated by metal stitching
3. Repair and coating application complete
4. Re-coated after 3 years in service

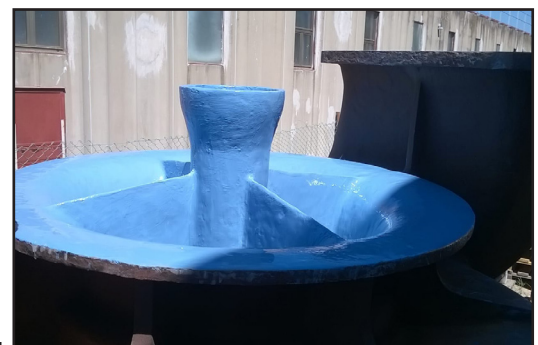
4.

The cost of replacement for the pump casing significantly outweighs using a coating as a sacrificial measure to be maintained/re-coated every 3-4 years. Belzona was selected for this application as alternative rebuild methods were unable to repair and terminate the cracked areas of the casing. The efficiency enhancement of the Belzona 1341 (Supermetalglide) introduced an additional cost benefit for the customer by reducing energy consumption of the pump. The pump was inspected 3 years into service and 80% of the coating was still in very good condition. The coating was refurbished before being put back into service.
