## BELZONA SUPERWRAP II SALVAGES SEWAGE TREATMENT PLANT

Two 200mm diameter carbon steel pipe elbows housed within a sewage treatment plant.

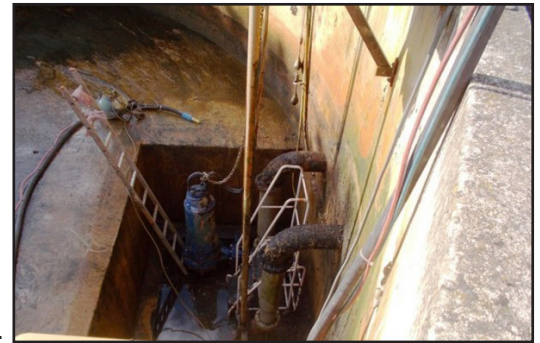
Carbon steel pipe elbows have been suffering over time from external corrosion due to weathering. The Customer required the restoration of metal loss on both pipes whilst adding further protection against future corrosion. The Customer was interested in a compliant composite solution to repair by reinstating the pipe's strength and to protect the pipework from further corrosion.

1. Corroded pipework.
2. Extensive corrosion leading to through wall defects.
3. Surface was prepared via grit blasting.
4. Finish application.
