## 4311 COATS A SULFURIC ACID TANK AT A CHEMICAL PLANT

The Customer wanted to coat a previously uncoated Sulfuric Acid tank.

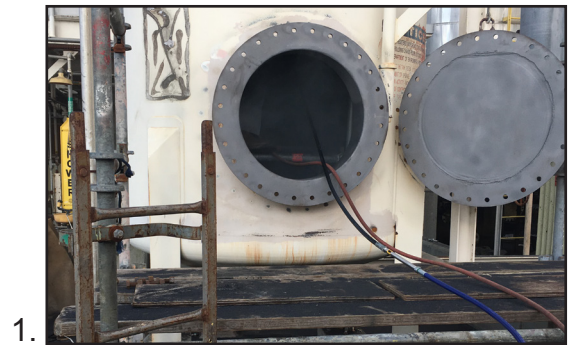
1. The tank after blasting with Black Beauty to get the required Belzona cleanliness standard.
2. A heated plural component pump the Customer used.
3. The spray team about to start.
4. Finished application of Belzona 4311.
