BELZONA BRINGS SHAFT BACK TO LIFE

Loss of shaft's bearing surface caused failure of the bearings.

Failed bearings damaged the shaft and prevented it from operating correctly.

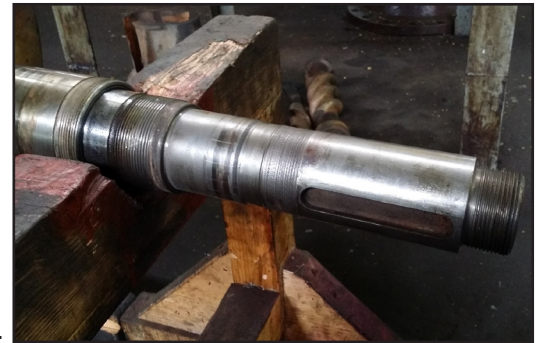
1. Worn shaft.
2. Closeup of worn shaft.
3. Rebuilt damaged area.
4. Complete shaft repair.

The application was carried out in accordance with a modified version of Belzona Know-How System Leaflet MPT-1. The shaft was roughly undercut 2 mm in depth, degreased with Belzona 9111, and rebuilt with Belzona 1121. Once it had cured solid, it was machined down to the correct dimensions.
