BELZONA REBUILDS DAMAGED DECK FLOOR

Corrosion occurring on deck floor

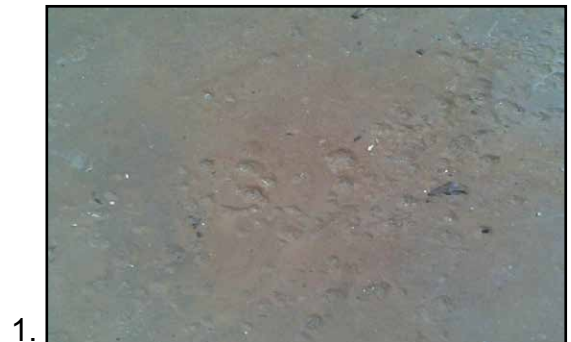
Severe pitting corrosion had occurred on the deck floor which needed rebuilding.
