## BELZONA REPAIRS AND PROTECTS RUDDER STOCK

Ships rudder stock needed rebuilt and protected

Ships rudder stock was suffering from the effects of erosion-corrosion

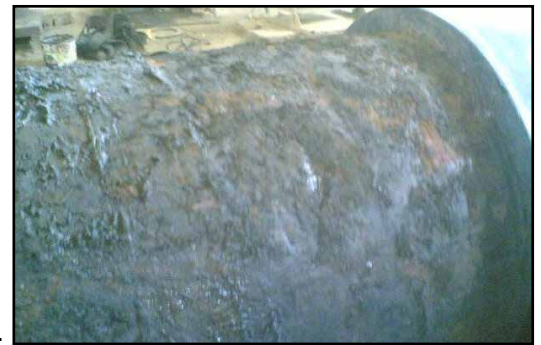
1. Corrosion-erosion damage.
2. Belzona 1111 successfully applied
3. Belzona 1321 successfully applied
4. Back in service after repair completion
