AHEAD OF TURNAROUND SCHEDULE WAS EASED UP WITH BELZONA HOT WRAP

Process Water Stripper Column

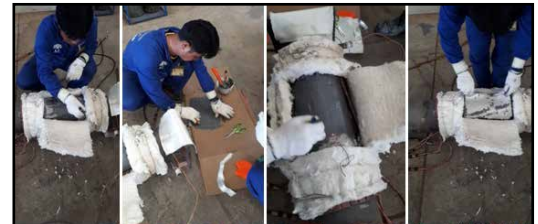
1. Mock Up Test
2. Belzona 1251 Application
3. Belzona 9371 Application
4. Belzona 5851 Application
