BELZONA RESTORES AND PROTECTS FLANGE FACE

Flange face restored due to the effects of galvanic corrosion.

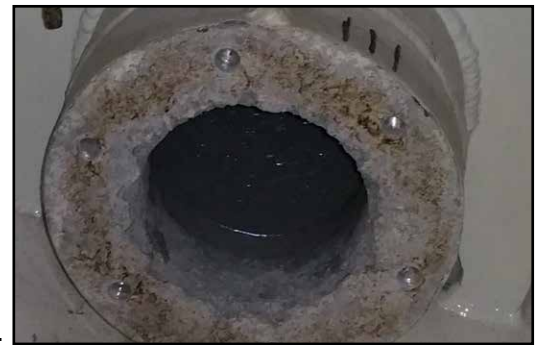
Heavy galvanic corrosion caused by dissimilar metals used in the manufacturing of the flange.

1. Flange before application
2. View after surface preparation
3. Flange face rebuilt with Belzona 1161
4. Flange fully restored and coated with Belzona 5831
