## TRANSFORMER BUSHING LEAK SEALED WITH BELZONA

Glasgow, Scotland

September 2013

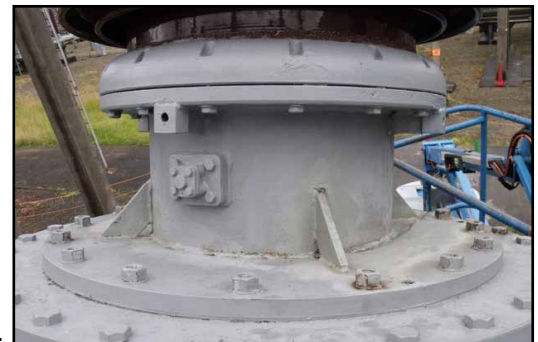
Two 19 inch diameter bushings on a transformer were leaking oil. The leaks were coming from cracks in four steel support struts.

1. Bushing before
2. Struts before application showing crack
3. Transformer after overcoating with Belzona 5831
4. Plate bond after overcoating with Belzona 5831
