BELZONA SAVES RUPTURED EFFLUENT TANK

Food Production Facility, UK

Leaking effluent treatment tank.

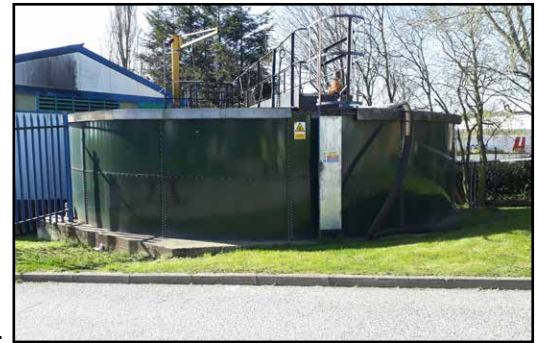
1. Effluent treatment tank
2. Extent of the leaks
3. Plates bonded over repaired areas
4. Sealed leaks around the base of tank

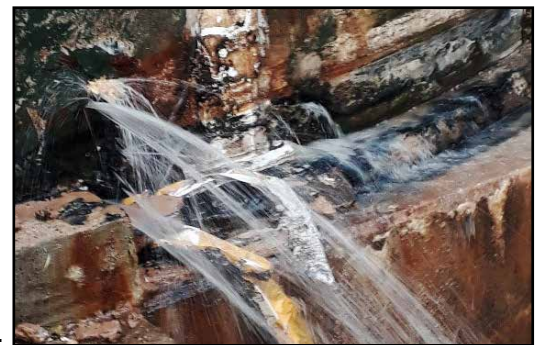
2.

Corroded and through-wall defects on effluent tank created leaks in the system.

The leaks were plugged with wooden wedges to stem the flow. The areas around the leaks were then repaired with Belzona 9611. When the area was sealed, the wooden wedges were cut flush with the tank wall. They then bonded over the entire failed areas with Belzona 1111. Finally, when the Belzona 1111 had cured a bolt was screwed in, sealing the leaks. Belzona 1111 was also applied in a 75mm band around the base of the tank, incorporating reinforcing sheets, to seal the multiple leaks around the base. This was completed in accordance with Belzona system leaflet TCC-01.
