BELZONA REBUILDS AND PROTECTS OIL TANK

Crude oil storage tank.

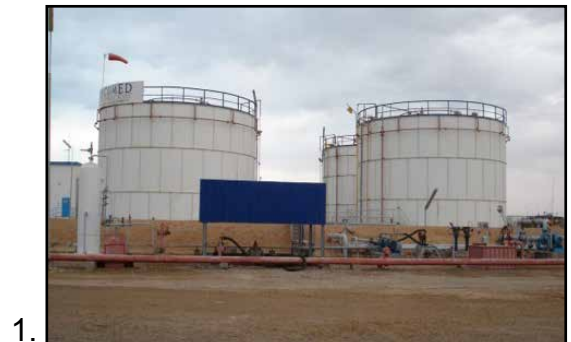
1. External view of the storage tank
2. Pitting at the base of the tank
3. Belzona 1121 plate bonding
4. Internal coating of Belzona 5811

Application was carried out in accordance with Belzona Know-How System Leaflet TCC-05. Belzona 1121 was used to fill in the pits of the localized damaged areas and plate bonding was used to restore any larger damaged areas on the base of the tank. Once the structure of the tank had been restored, 2 coats of Belzona 5811 were applied to the lower section of the tank.

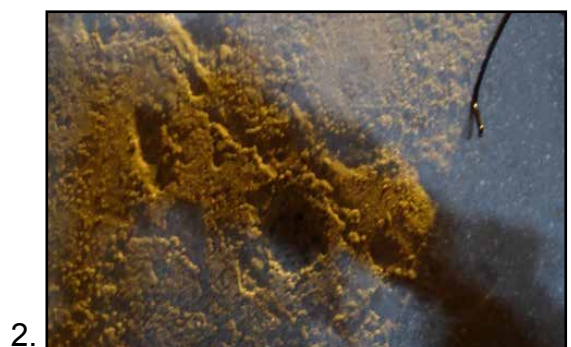
Severe pitting was present at the base and lower section of the tank wall, this was a result of a mixture of water and also hydrocarbons found within the crude oil. As the density of the water is greater than the hydrocarbons, the water will sit at the bottom of the tank causing corrosion in this lower section of the tank.
