## IN-SITU BELZONA SHAFT REPAIR AT CEMENT PLANT

Cement Plant, Yorkshire, UK

Worn cement screw shaft 1 1/2" diameter

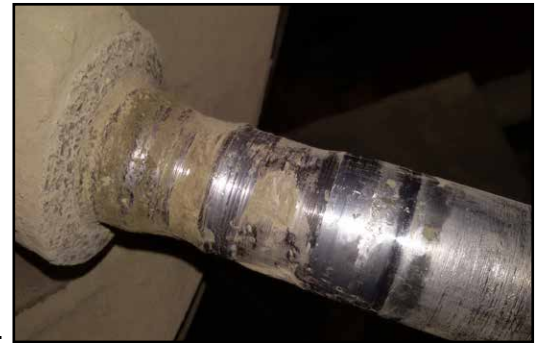
Heavy wear of the shaft on the cement screw element had occurred and required repairing before potential equipment failure.

1. Worn shaft
2. Shaft area prepared for application
3. Former clamped in position after Belzona 1111 application
4. Former removed revealing fully cured Belzona 1111 repair
