## BELZONA REPAIRS DUCT ON FPSO

Severe corrosion affected the ER Duct lines creating holes and metal loss. Atmospheric air is the medium that passes through duct.

The ER Duct from the compressor was damage from severe corrosion leading to holes in some areas.

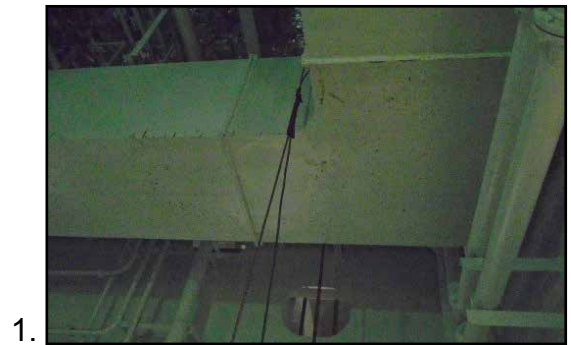
1. General view of the ER Duct
2. Surface preparation on the ER Duct
3. Cleaned and degreased with Belzona 9111
4. Applied Belzona 1111 to rebuild lost metal and Belzona 5811 to protect surface corrosion
