BELZONA REPAIRS OIL TANK LEAK AT A POWER PLANT

Steel tank Oil Reservoir

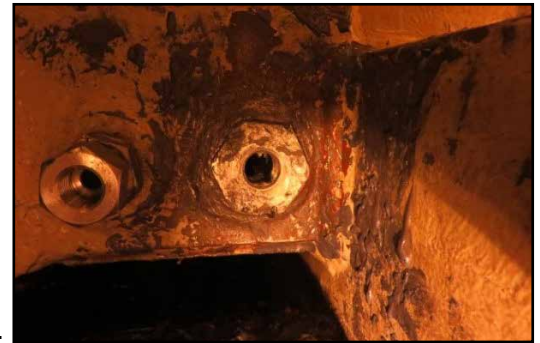
The down deck of the tank had been subjected to severe corrosion leading to drips leak of the oil. This needed to be fixed urgently for the plant to continue operating and also avoid environmental hazards from leaking oil.

1. Oil tank leak area
2. During application of Belzona 1212 to the pinhole on the oil tank
3. Belzona 1212 application completed
