CONDENSER RUBBER LINER REPAIRED WITH BELZONA

Power plant - Takoradi, Ghana

Rubber liner of a Steam Condenser

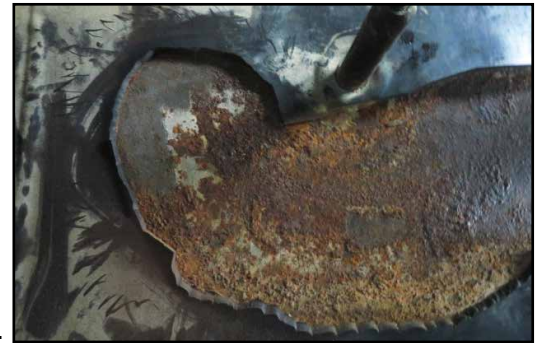
Existing condenser rubber liner peels off and corrosion starts to attack the metallic surface.

1. Before the surface prep and application of Belzona 2111 and Belzona 1111
2. After Surface preparation using bristle blaster
3. After the application of Belzona 1111
4. After view when Belzona 2111 was applied
