BELZONA CHOCKING REPAIR ON GEAR MOUNTING

Szarbków, Poland

Re-levelling a steel foundation slab of a mill gear and the foundation of the mill on the plate.

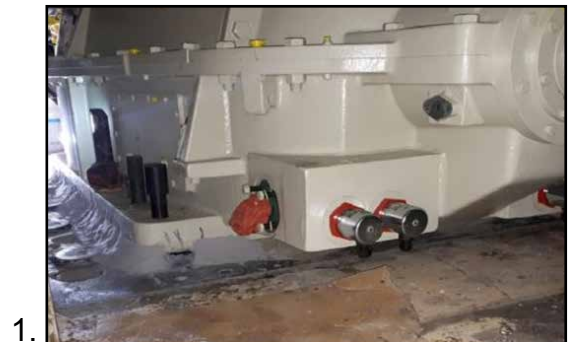
Gear mounting not working at full efficiency due to misalignment. Repair work need to concrete area prior to chocking.

1. Gear Equipment Picture
2. Application of Belzona 4111
3. Application of Belzona 7111
4. Chocking application complete.
