BELZONA CONCRETE TANK REPAIR

Repairing and coating of a concrete tank used for storing potable water.

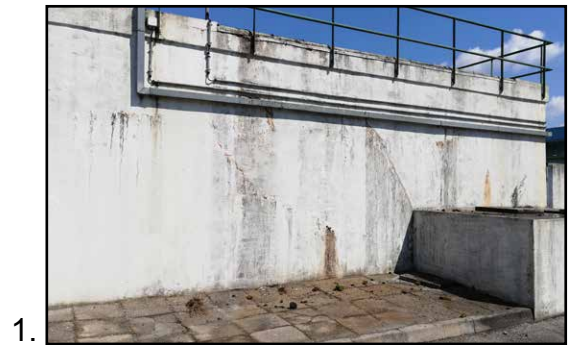
A large concrete tank used for supplying potable water for 3 of the neighboring cities was severely damaged internally. The cracked concrete was causing water to leak out of the external wall of the tank onto the road.

1. External view of the concrete tanks
2. Pressure washing/cleaning the concrete
3. Filling in the damaged concrete with Belzona 1161
4. Coating of Belzona 5831
