## BELZONA REPAIRS FLANGE SURFACE OF A FLOATING HOSE

End flanges of a floating hose are subjected to a severely corrosive and erosive environment at sea. The hose has been brought back to shore for routine maintenance.

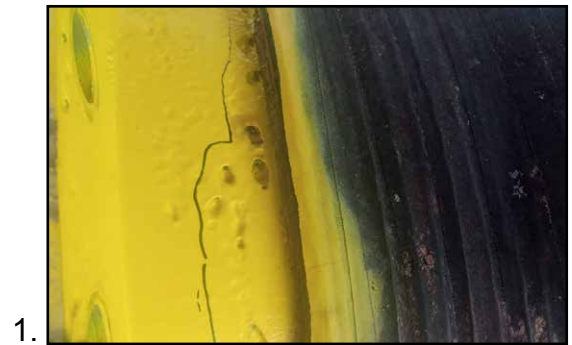
The neck of the floating hose leading to the flange area was suffering from severe pitting due to the corrosive and erosive sea water environment, several millimeters of steel had been lost.

1. Overview of the damaged area
2. Surface preparation
3. Defect area marked out and debris removed
4. Completed application
