BELZONA COLD REPAIR TO LEAKING PIPE JOINT

A pipeline carrying gasoline at a petrochemical facility.

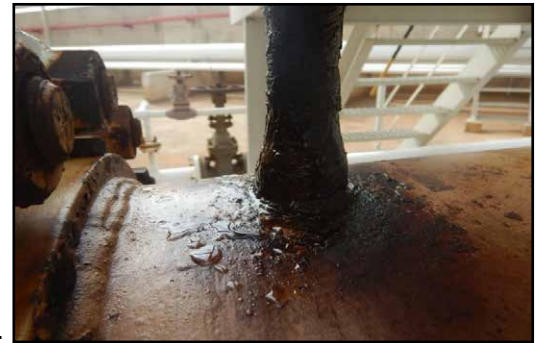
A 1" pipe branching from the 14" main line had a crack and a leak at the joint area. As the line contains flammable fluids hot work is not an option.

1. Defect area
2. Surface Preparation Complete
3. Application in progress
4. Completed repair
